# ACOUSTICAL ANALYSIS

Washington Square Village  
Silver Towers  
Greenwich Village, NY

Prepared for:  
NYU Operations

25 September 2012

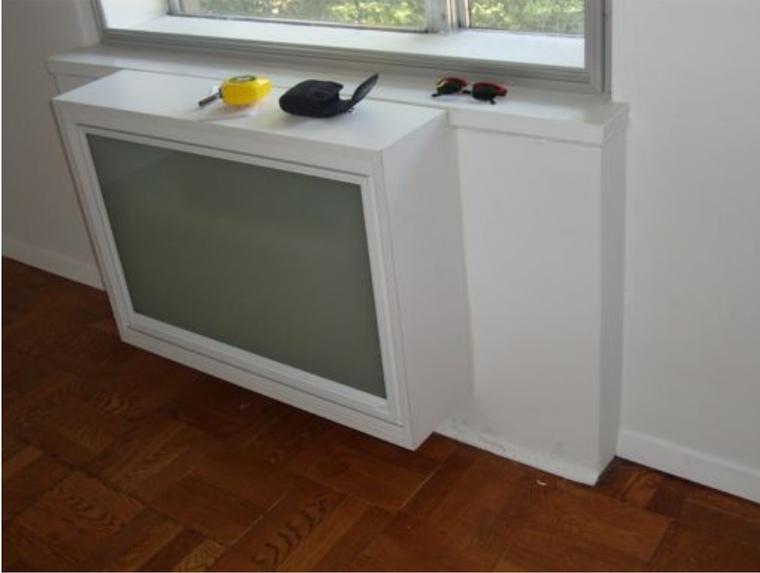
Interior acoustical air conditioner cover

TEST #2B: The second EIS minimum included the same aluminum frame storm window assembly with the new through wall air conditioner unit, some sealing of the air conditioner sleeve perimeter and the installation of a custom fabricated sound attenuating wood and glass air conditioner cover. The wood cover extends around the air conditioner and has a removable glass door at the face of the air conditioner. When the air conditioner is in use, the cover must be removed.

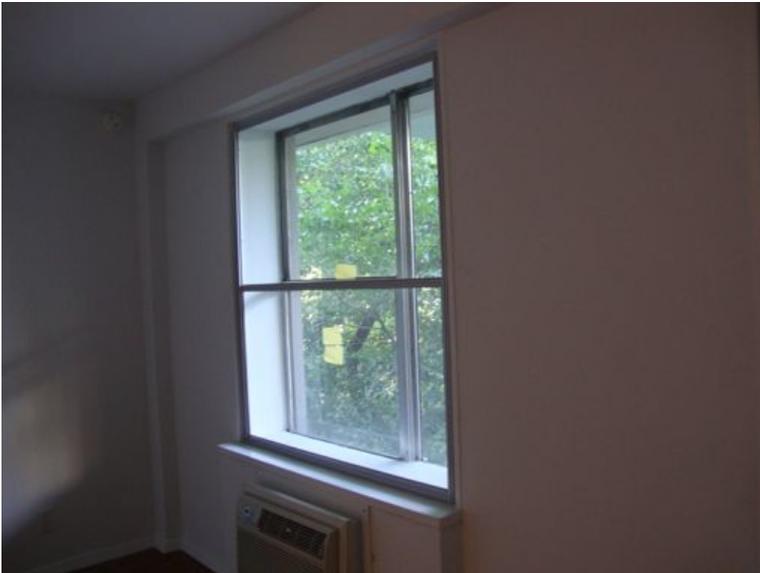
Interior storm windows

TEST #2A: The EIS report provided for two variations on the minimum requirement of which this test was the first. This test included resealing of the existing single pane windows, metal to metal and metal to glass components, installation of a standard aluminum frame double hung interior storm window and the installation of a new through wall air conditioner unit. The air gap between the existing glazing and the interior storm was measured as 8", the gap was lined with homasote at its perimeter. The storm windows consisted of 1/8" thick single pane glazing.

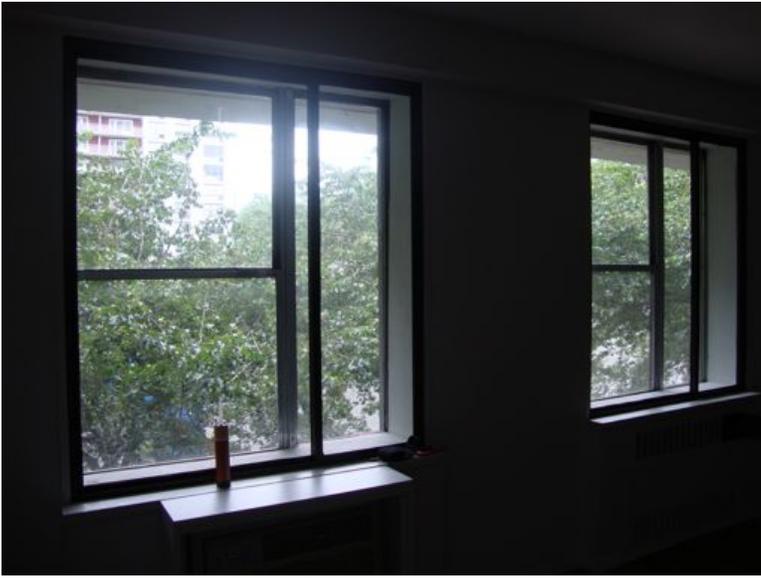
Interior acoustical windows

TEST #3A: This test is the first improvement test over the EIS minimum requirements. This test included the resealed existing double hung single pane aluminum window, the installation of a horizontal sliding acoustical interior storm window, spaced 8" from the existing window, with homasote lining at the

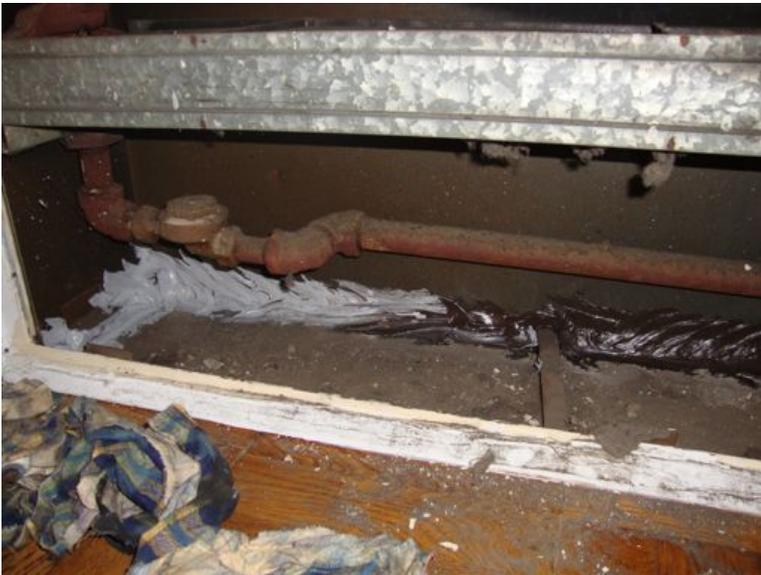
Improvements at area in radiator cabinet

perimeter of the air gap. The acoustical interior windows consisted of 1/4" laminated glass. The new air conditioner with perimeter weather stripping remained in place. This assembly was tested both with and without the cover on the noise blocking AC assembly. Additional sealant work was performed at the radiator enclosure, where pipes penetrated the wall of the cabinet and where the cabinet was found to be open along the bottom edge.

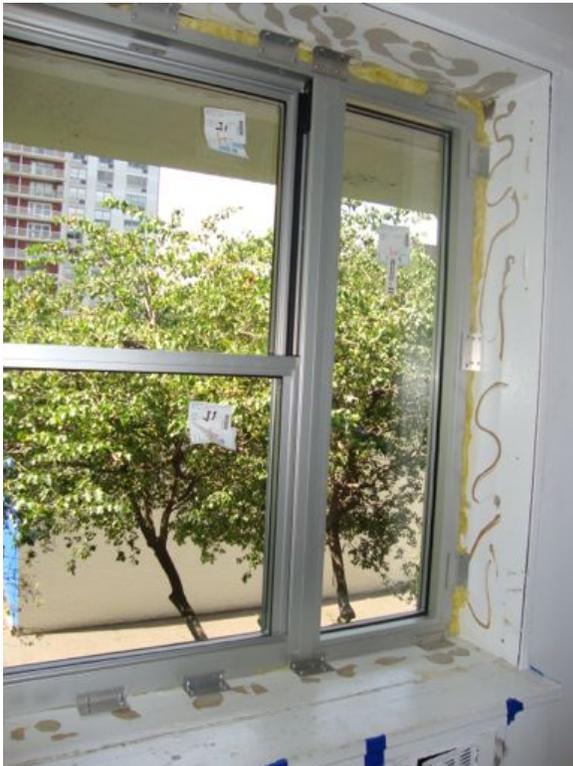
Complete window replacement, in progress

TEST #4A: This test provides for the installation of a retrofit aluminum framed window assembly. This assembly includes the removal of the existing frame (except the perimeter members) as well as the existing glazing and louvers. New fixed and double hung sashes replicating the existing configuration were installed, comprised of a 3/16" clear annealed exterior lite, a 5/8" spacer and a 1/8" clear annealed interior lite with argon gas between the inner and outer panes. New louvers and insulated panels were installed over the existing panels, with insulation in between. The new through wall AC unit was installed with the sealing of the AC perimeter. This test was also run both with and without the interior sound attenuating air conditioner unit cover. Batt insulation was installed between the new blank panel and the existing blank panel at the exterior, in front of the radiator cavity. The previous sealant work remained in place.

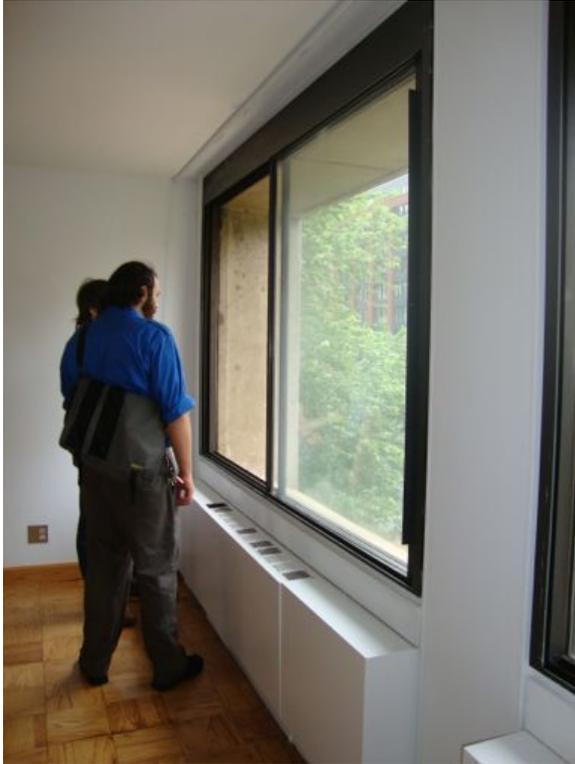
TEST #1: The in situ conditions were tested in order to establish a baseline off of which the remainder of the tests would be judged. This includes large single glazed sliding windows, and Remington Model K PTAC unit surrounded by an open metal cabinet with a louver and blank metal panel facing. There is no back up masonry wall.

Typical interior condition (unimproved), living room

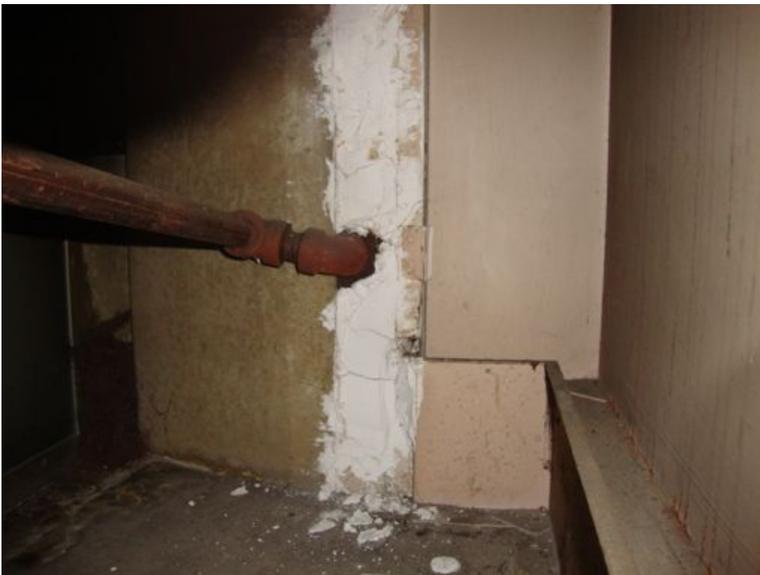
PTAC cabinet interior conditions (unimproved)

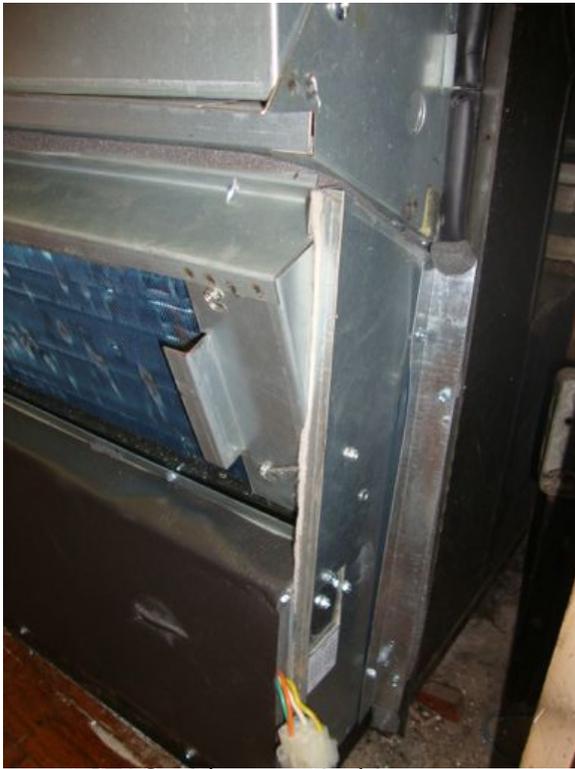
Replacement PTAC with acoustical improvements

The scope also included the installation of an acoustically improved Remington Type K PTAC unit within the existing sleeve. There were no improvements to the surrounding area within the under window enclosure.

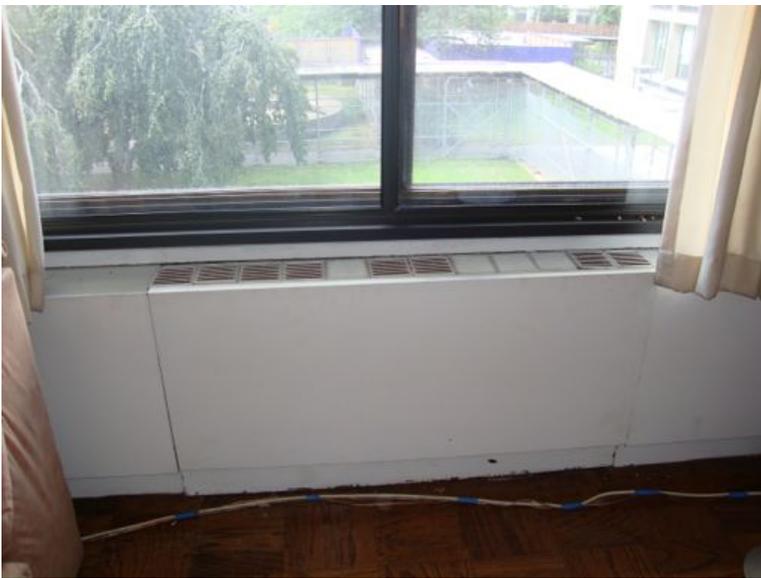
Interior storm windows

TEST #2: This test was run to address the EIS minimum requirement. This test included resealing of the existing single pane sliding windows, metal to metal, metal to concrete and metal to glass components and installation of an aluminum frame sliding interior storm window. The air gap between the existing glazing and the interior storm was measured as 2-5", as it is limited by the vents on top of the PTAC enclosure. The storm windows consisted of 1/8" thick single pane glazing.

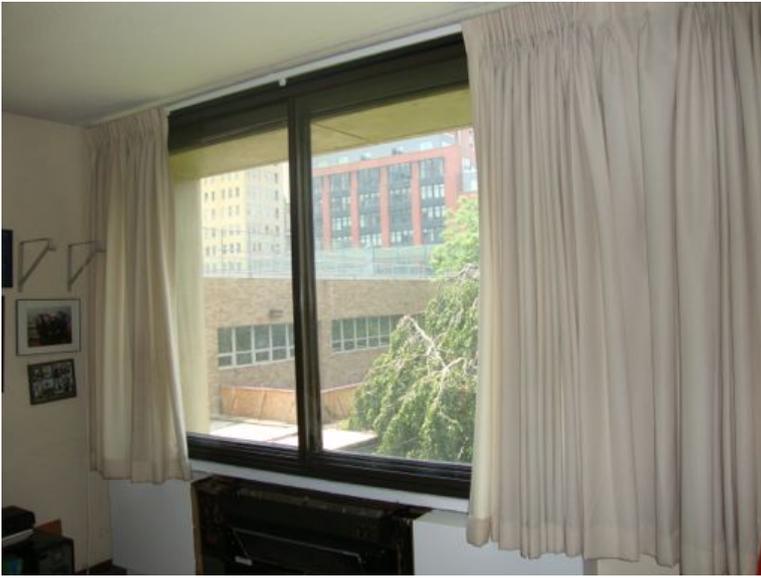
Interior acoustical windows

TEST #3A: This test is the first improvement test over the EIS minimum requirements. This test included the resealed existing sliding single pane aluminum window, the installation of a horizontal sliding acoustical interior window, spaced 2-5" from the existing window. The acoustical interior windows consisted of 1/4" laminated glass. The acoustically improved Remington Type K PTAC used in Test #2B was reinstalled for this test.

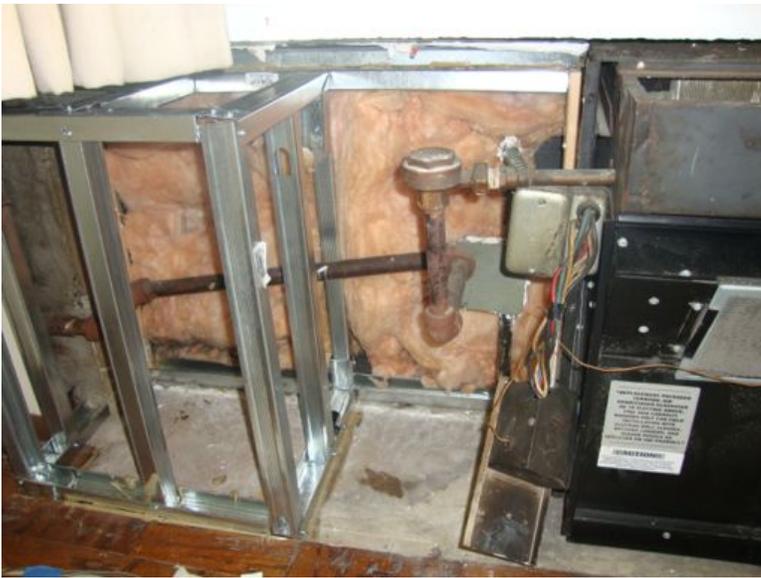
Test 3C / 3D improvements within PTAC cabinet area (original PTAC in place at time of photo).

TEST #3C: This test included the resealed existing single pane sliding windows, the installation of a 1/4" laminated glass acoustical interior window spaced 9" from the existing window, the installation of a replacement sound attenuated PTAC and retrofit sleeve, the construction of a double layer 5/8" Type X gypsum wall board barrier separating the interior from the exterior, acoustical mat installation on existing surfaces, and a new MDF PTAC cabinet (replacing the existing metal cabinet).

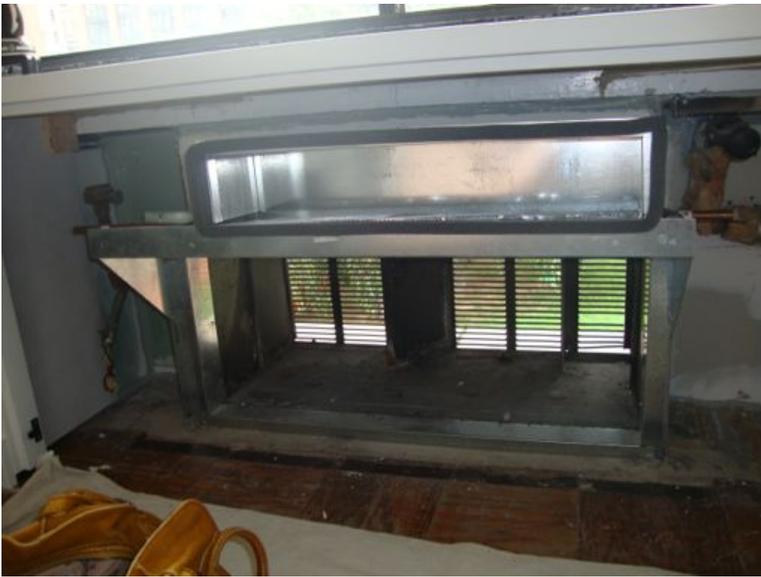
Test 3C / 3D completed interior partitions, retrofit PTAC sleeve in place.

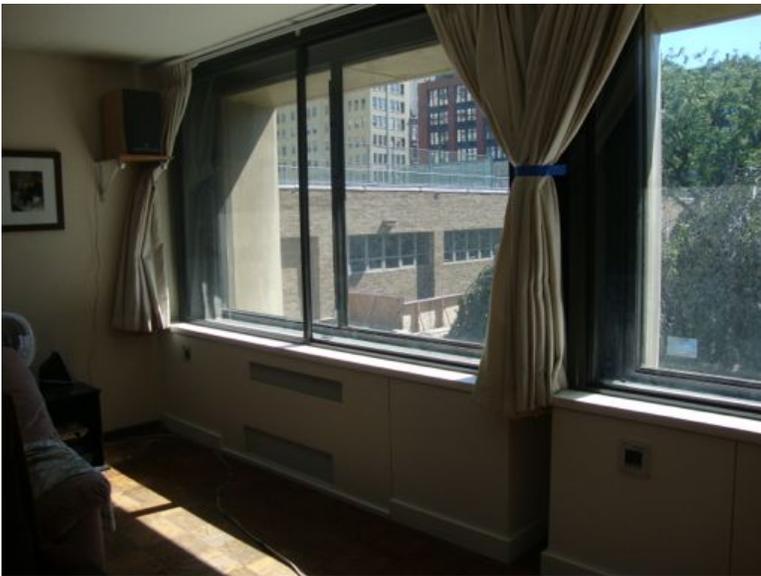
Test 3C / 3D Completed installation.

TEST #3D: This test replicates test #3C with the additional improvement of 3/8" laminated glazing on the acoustical interior windows in lieu of the 1/4" laminated.
