1 Washington Square North

Address:	1 Washington Square North
Building Name:	1 Washington Square North
Construction Date:	1833; altered 1880
Original Owner:	Sailor's Snug Harbor; William Beach Lawrence, original lessee
Original Architect:	unknown
Original Use:	Residential
Historical Notes:	One in a row of six (1-6 Washington Square North) Greek Revival houses built in 1833 on undeveloped land leased to builders by the owner, Sailor's Snug Harbor. NYU acquired the building in 1949.
Landmark Status:	Greenwich Village Historic District
Building Type:	R1
Number of Stories:	3.5 + basement
Street Facades:	Washington Square North (south) and University Place (east)

Existing Condition Photographs

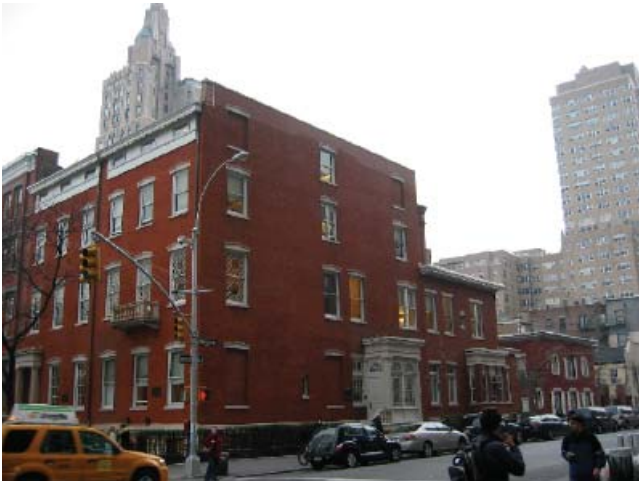
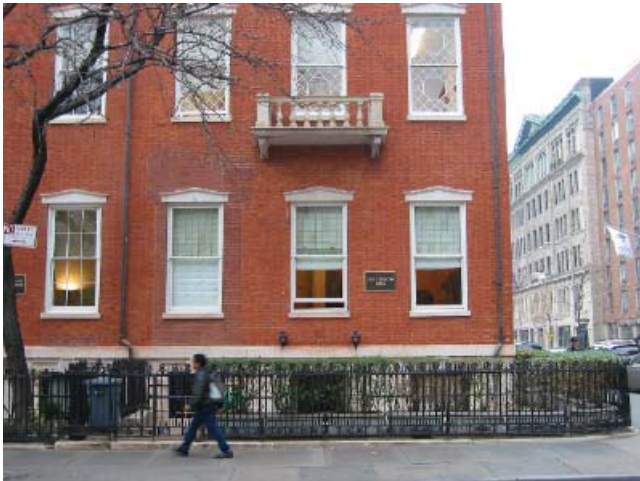
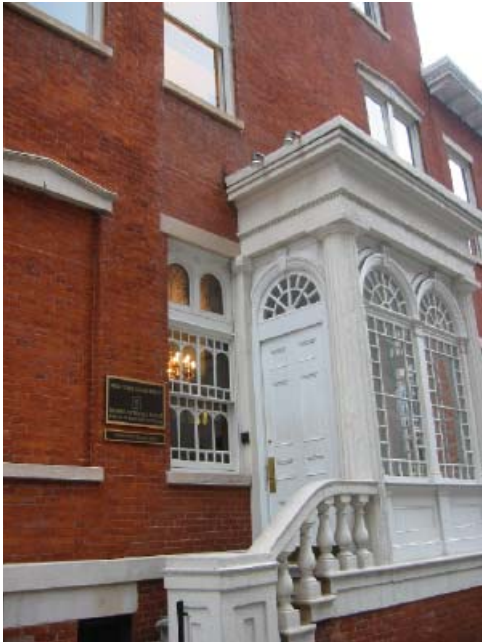
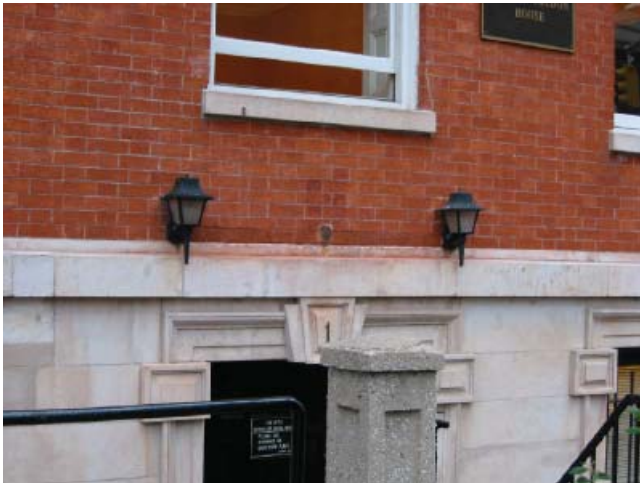
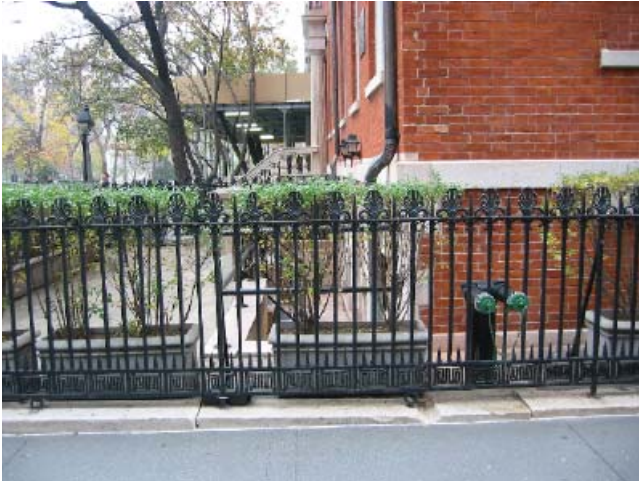
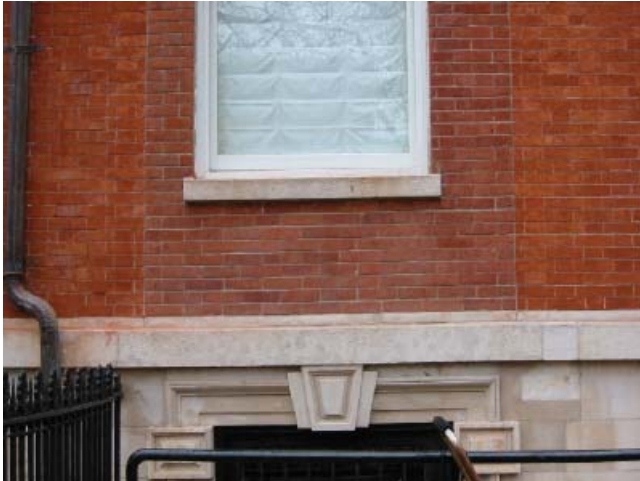
- Red pressed-brick facade with Tuckahoe marble lintels, sills and base.
- Original wood cornice (100%).
- Wrought-iron fence, Tuckahoe marble fence-curb and bluestone paving.
- Two-story "ell" at east facade is historic alteration.
- Historic alteration in 1880: leaded-glass windows at 1st story, and diamond-paned windows at 2nd story.
- Historic reconfiguration of 1st story window and door openings on south elevation. Original door on south elevation removed and replaced with window; masonry opening was filled with non-matching bricks.
- Window inserted at ground floor of east elevation, north of projecting bay. Masonry opening surrounded by non-matching brick.
- Extensive brick replacement around the door on east elevation is historic.
- Brick infilled windows on the east elevation. Note: there is evidence of similar renovation on the west façade of 13 Washington Square North.

- Small lantern-style light fixtures installed into brick.
- Wood 1/1 windows at basement and 3rd story are not original.
- Brass plaque and other signage are not original to building.
- Sheet metal cornice along "ell".
- Tuckahoe marble patched with a non-matching patch mix; marble at the projecting bay is parged and painted.
- Parapet on east side rebuilt with non-matching brick.
- Brick was painted red at some point; traces of paint remain.
