Block: 550 Lot: 13

Original & Historic Features

7-13 Washington Square North

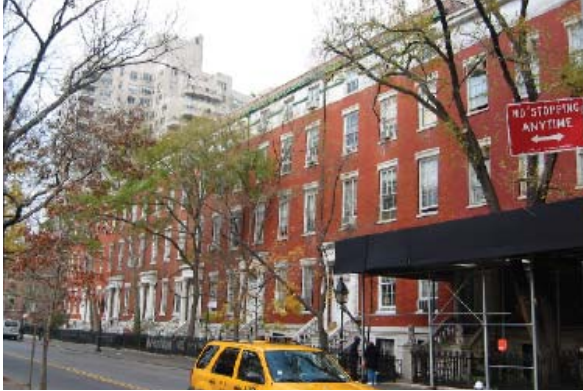
Washington Square North facade

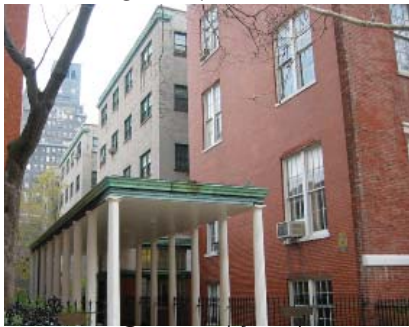
Courtyard facade

- White-glazed brick facade with red brick sills, colonnaded entrance, glass-block entrance ell.
- Massing characterized by recessed light courts.
- 6/6 wood window original (100%).

- No major alterations noted.
- Some window openings filled with a/c units.

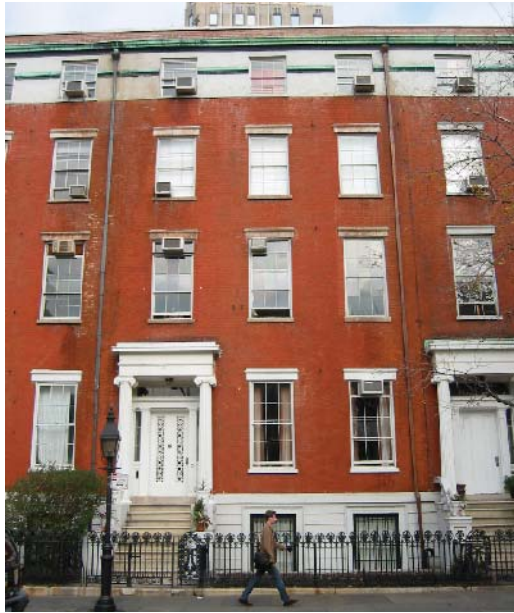
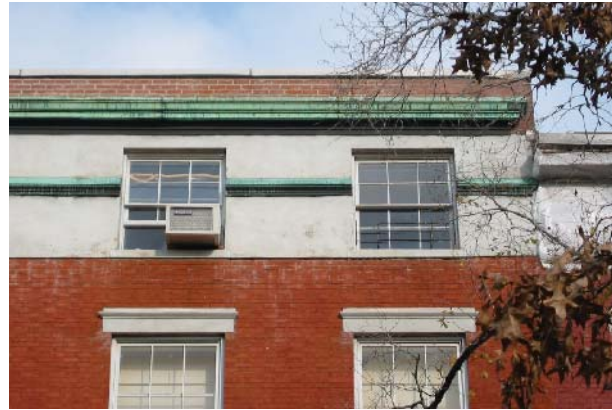
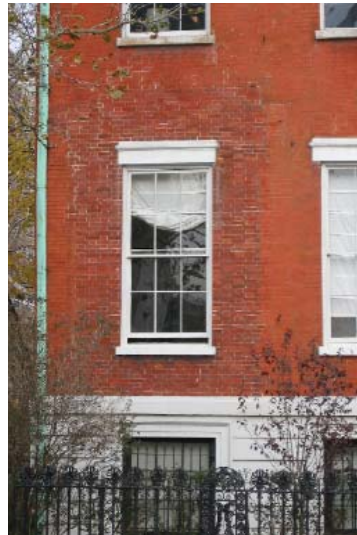
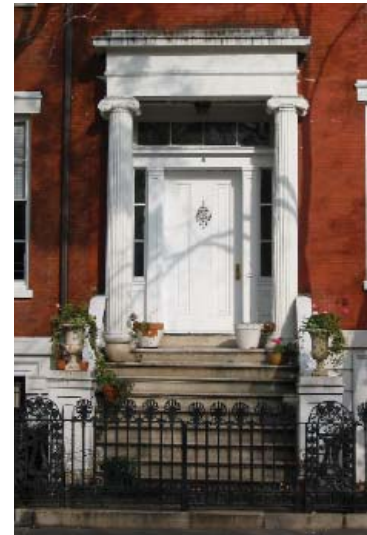
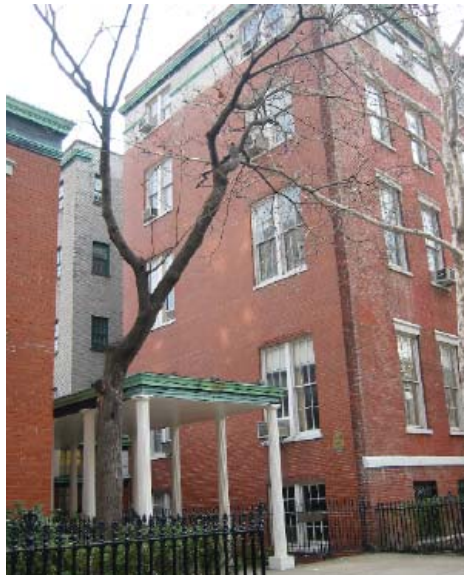
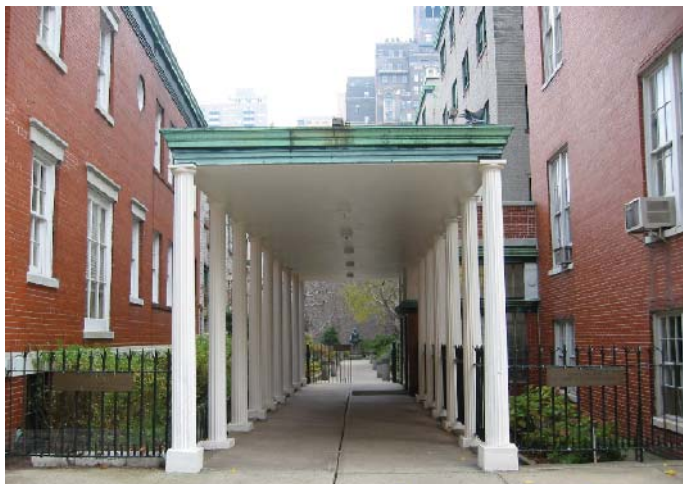
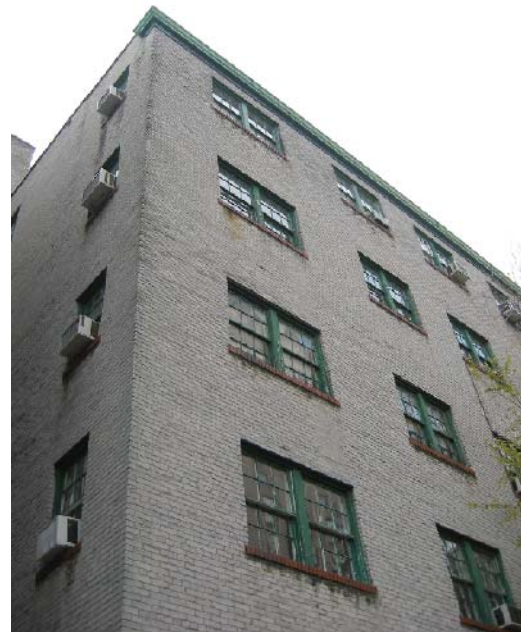
Existing Condition Photographs

- Some window openings filled with air-conditioning units.
- All pressed brick painted red.
- Selective repointing between 9 and 10.
- Several leader clips embedded in brick on south facades.
- Marble painted at basements and ground floors.
- Non-historic door at 12.
- Spot lights installed above each door are non-historic.
- Non-historic paint on glass, numbers on doors.
