Address: 3-5 Washington Place,
282-284 Mercer Street

Building Name: 5 Washington Place

Existing Condition Photographs

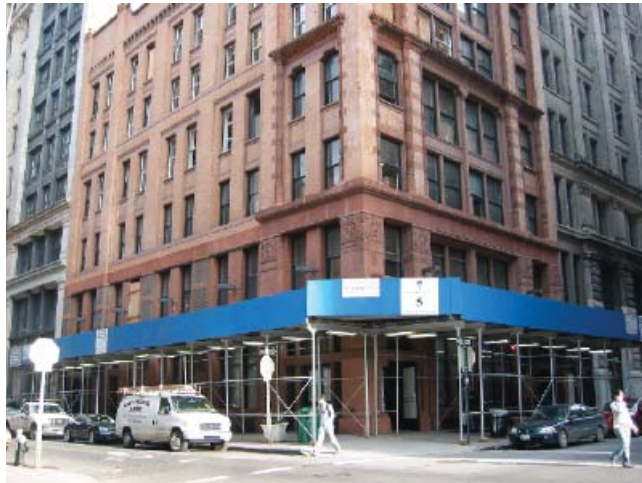
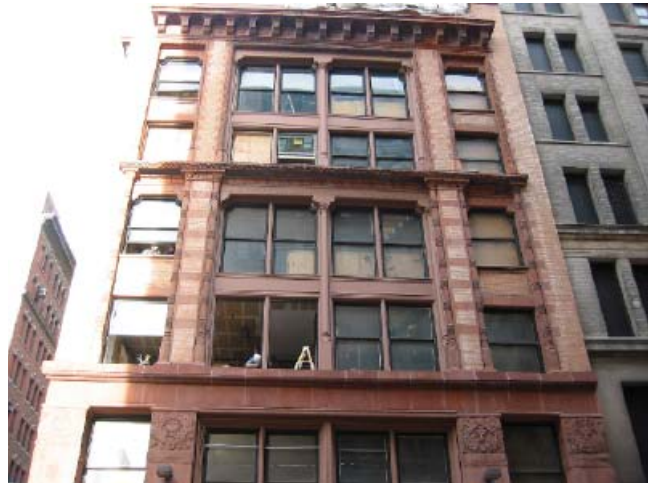
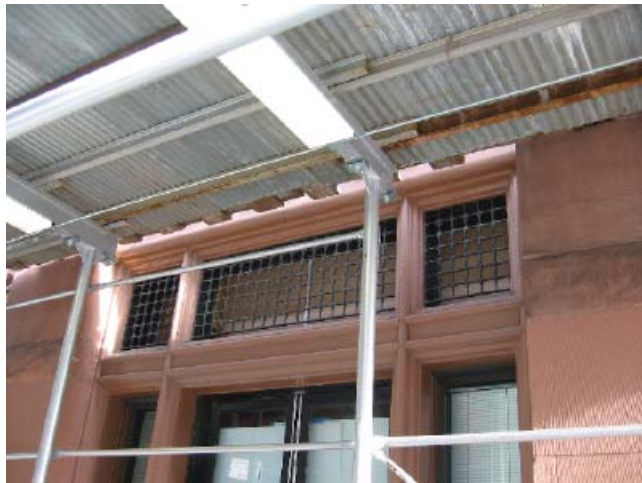
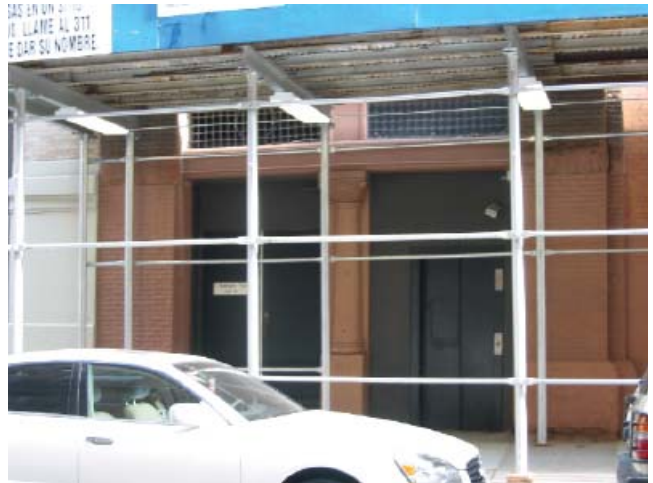
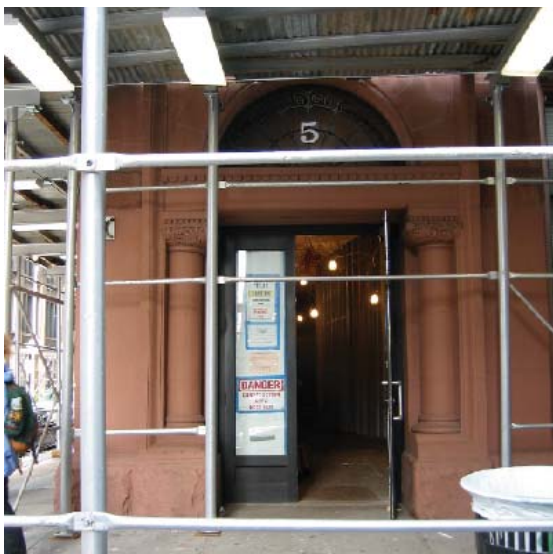
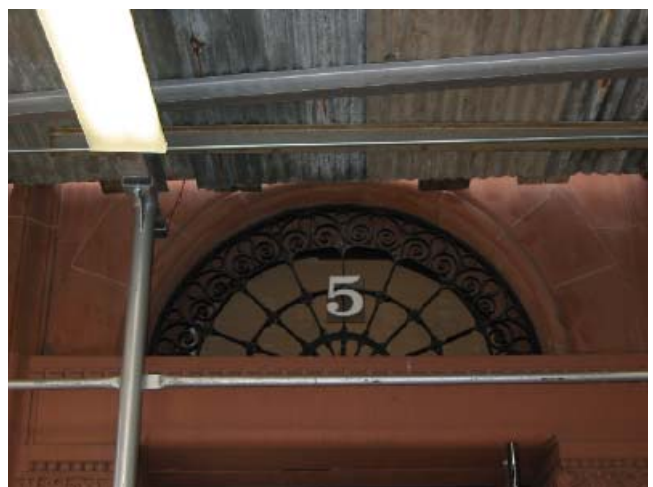
- 11/06, facade work is underway. Original one over one wood sash are being replaced with one over one aluminum sash.
- Cornice removed from 2nd story, west elevation.
- Sill courses at 3rd and 5th stories, west elevation, have been panned.
- Color matching in recent painting and stone restoration is slightly off.
- Some windows have been filled with louvers.
- Rooftop addition and sheet metal covered parapet are visible from the street. Rooftop addition is shrouded at time of survey (11/06).

- Glass and aluminum replacement doors at main entries. Original cast-iron enframing at service entry has been panned with aluminum; replacement doors are sheet metal.
- Storefront windows are aluminum replacements.
- Security lights, most mounted directly into masonry.
- Signage: non-historic wood numbering attached to the wrought-iron transoms.
